SCOPAC Timber Groyne Workshop 24th March 2010
NOC 10am

Presentation 1: Andy Bradbury (AB)-Introduction

Presentation 2: Pete Ferguson (PF)-NFDC groyne repair and maintenance-recent advances

Presentation 3: Dave Harlow- Bournemouth Timber Groynes

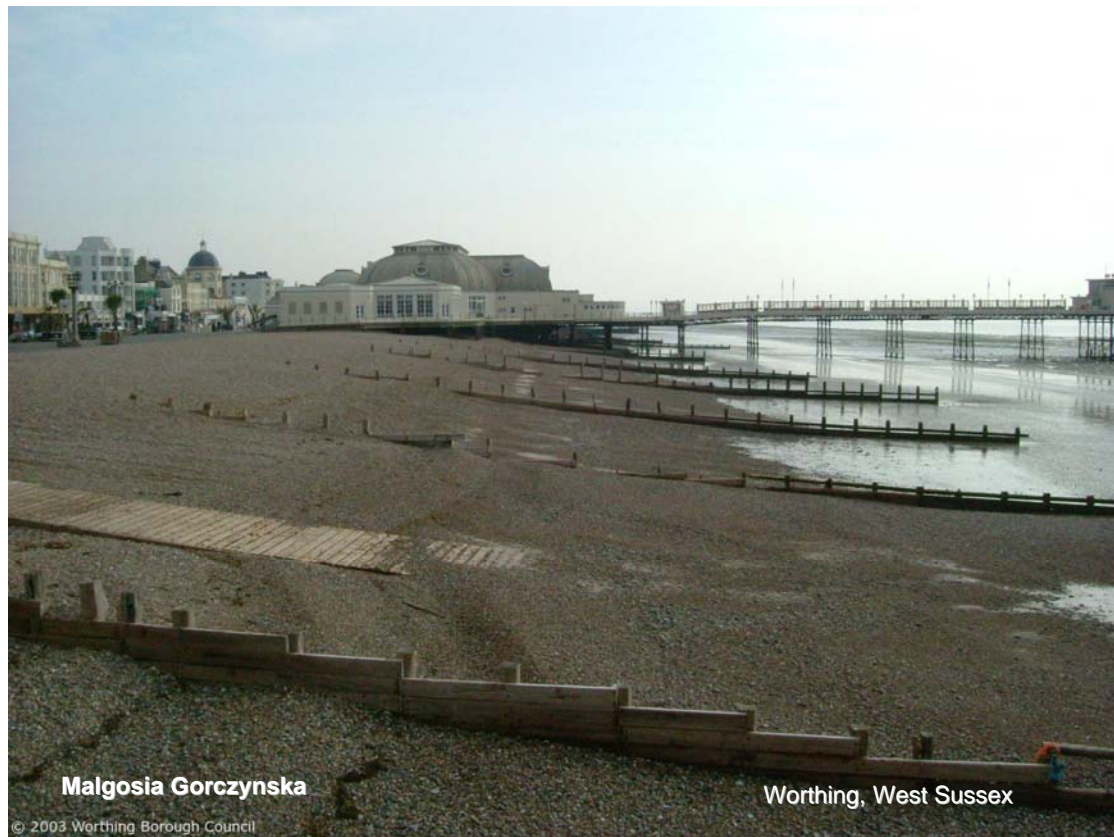
Why are groyne made of timber?

- DH: The close spacing of the timber groyne and their narrow width allows more beach users compared with rock structures which are so much wider.
- Timber is easier to maintain at low tide than concrete.
- Rock is also highly opposed in some areas by residents who are used to timber.

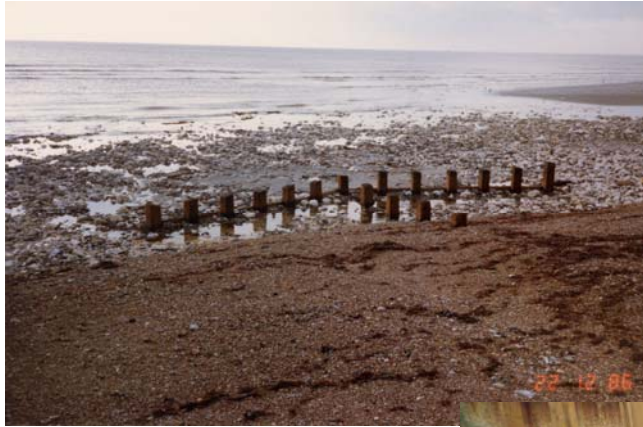
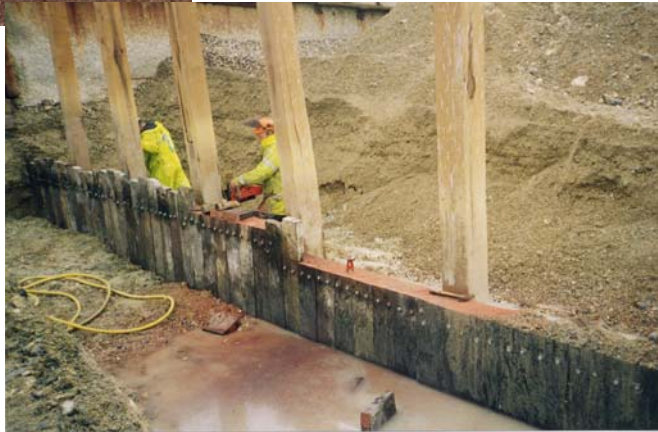
Recycled planks in vertical positions are fitted into a groove in the chalk substrate to prevent undermining of the structure. I believe this is known as a fishtail groyne. Perhaps somebody can advise on its use/purpose/what it achieves?

- AB: Fishtail groynes are used to change/control the direction of sediment flow. Normally made of rock rather than timber.

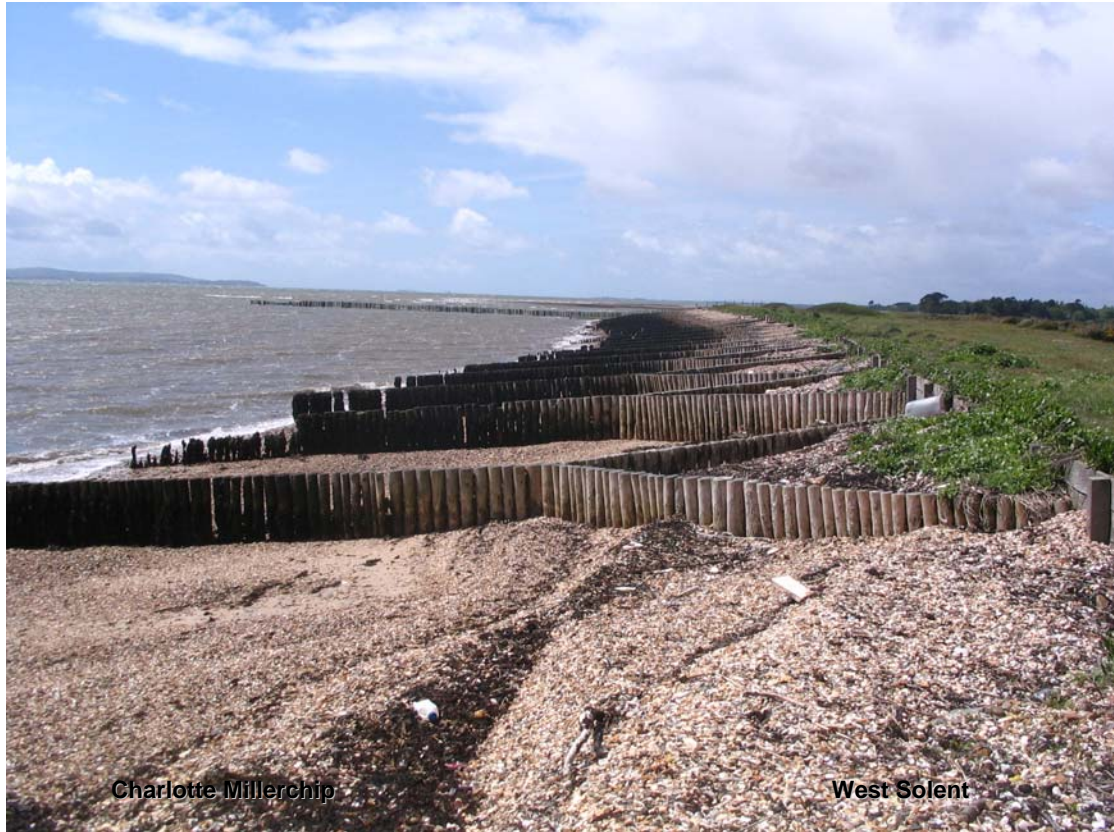
Can anyone explain why there are Y shaped groynes here?

- AB: These are Y shaped groynes designed by Billy Nicholls using local materials for private landowners. They provide some protection to the backshore to buffer against wave action and store sediment in the V shape.

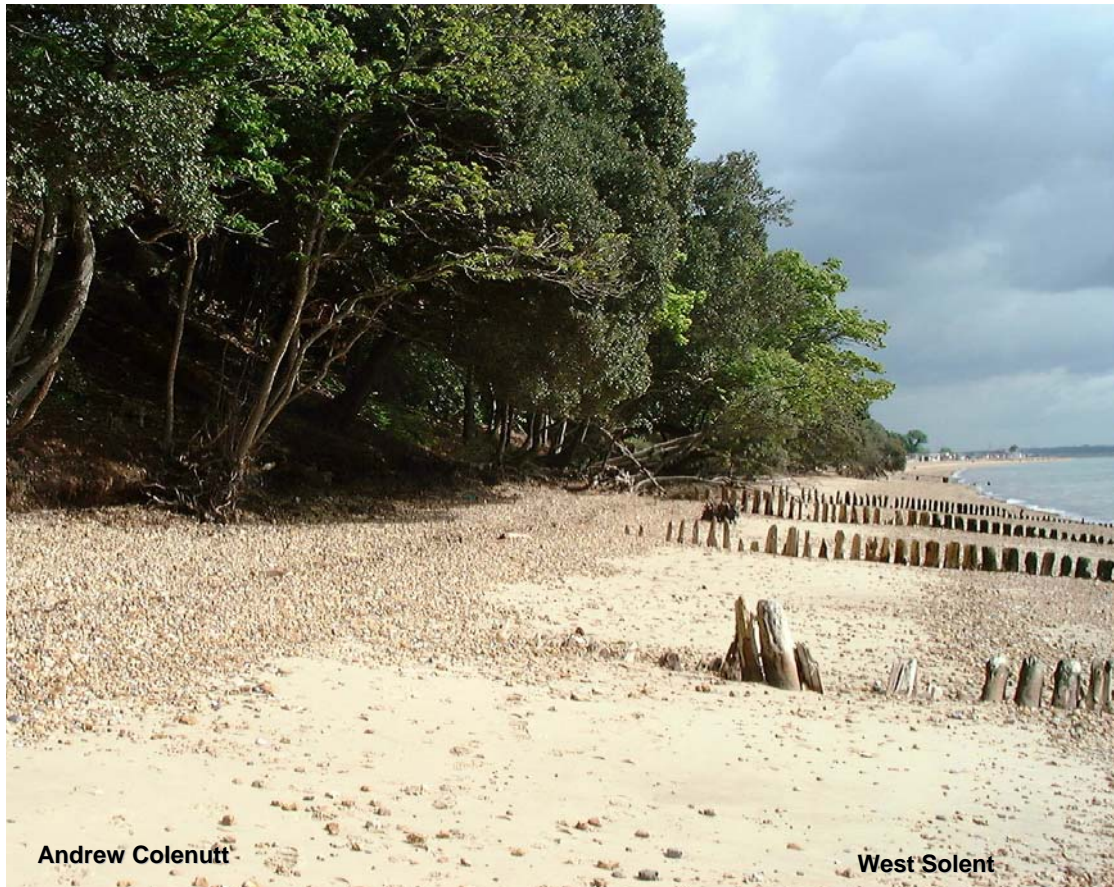
The photo shows a privately owned timber groyne field in the west Solent - the issues for discussion are, the requirement for landowner management plans and the need to assess the implications of whether defences are maintained or not on landowners and adjacent neighbouring frontages

AC: Private and decayed groyne fields may be left in so that if the landowner wishes to upgrade defences later it may be classified as maintenance. However, if the beach is open to the public following the Marine and Coastal Access Act, landowners have raised health and safety concerns associated with these defences in their current condition.

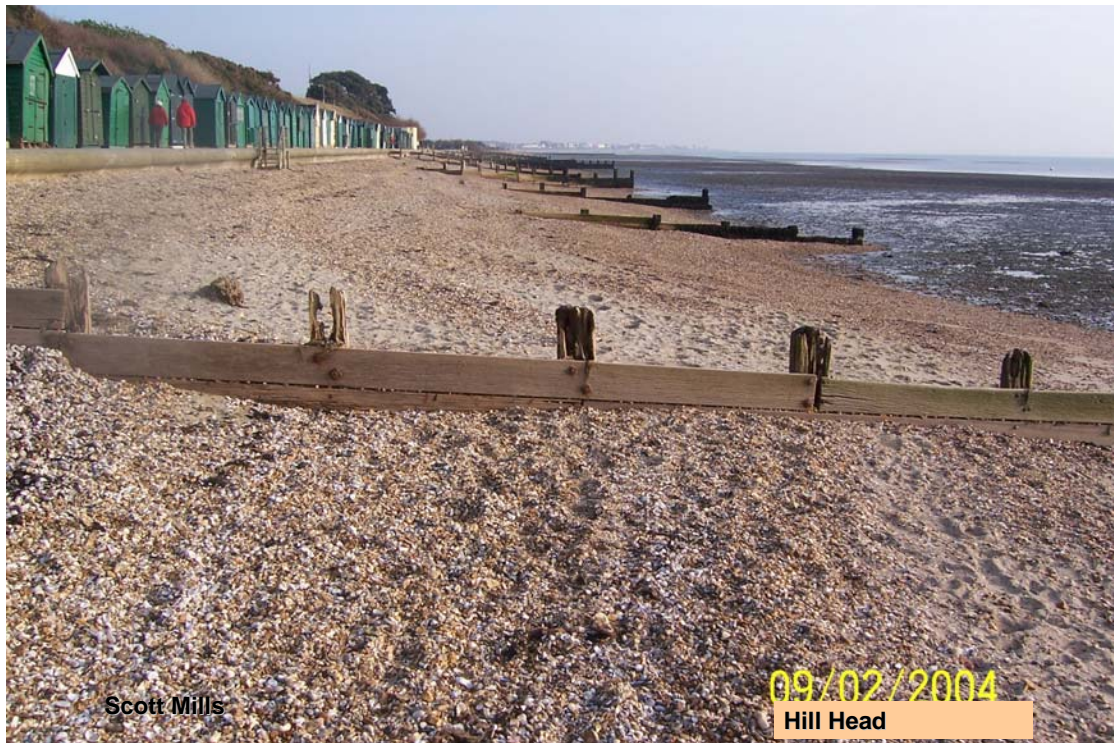
What could be done about the degraded piles at Hill Head?

- Harry: Cut back the piles and either replace or add new piles by digging to the side and bolting on to existing structure. Check that the plank has not deteriorated aswell.
- SW: May well be a waste of time. Revert to rock groynes?
- AC: Get rid of it? AB: No, don't take it out.

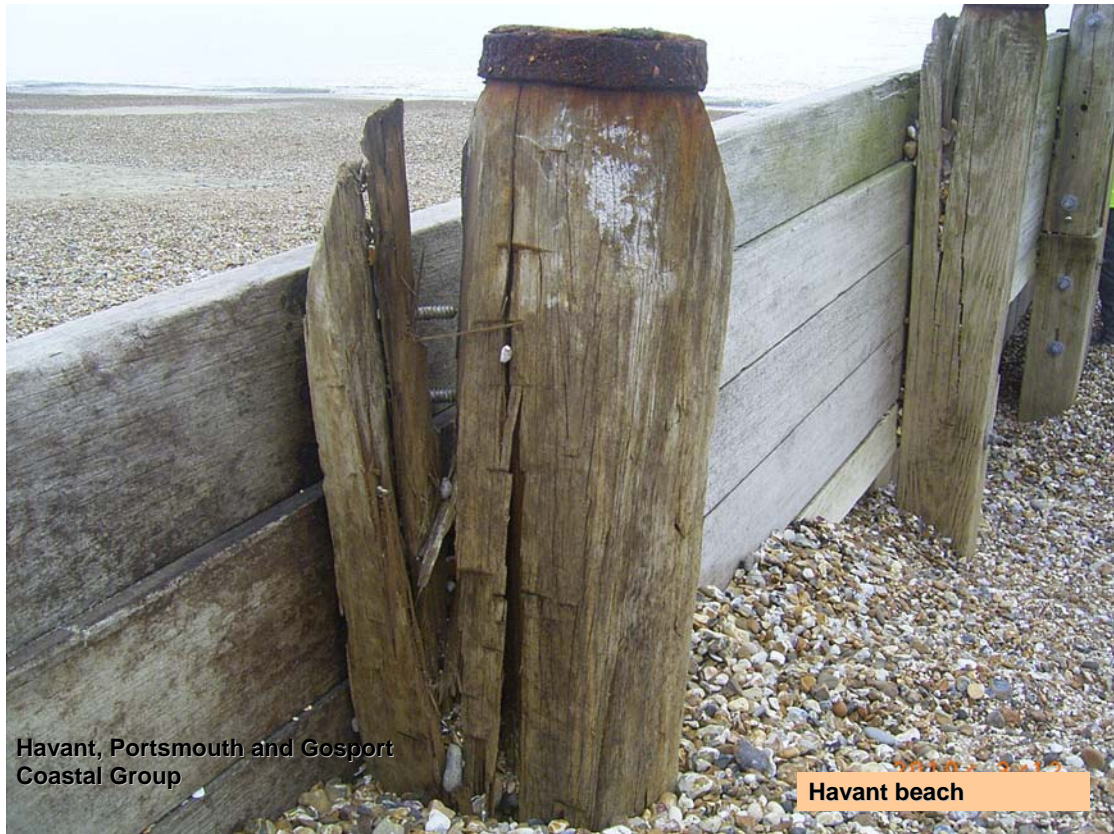
Piles have pulled away but only localised movement.

- Possible that the pile is not deep enough as sediment levels are equal on both sides. Below is solution to problem.

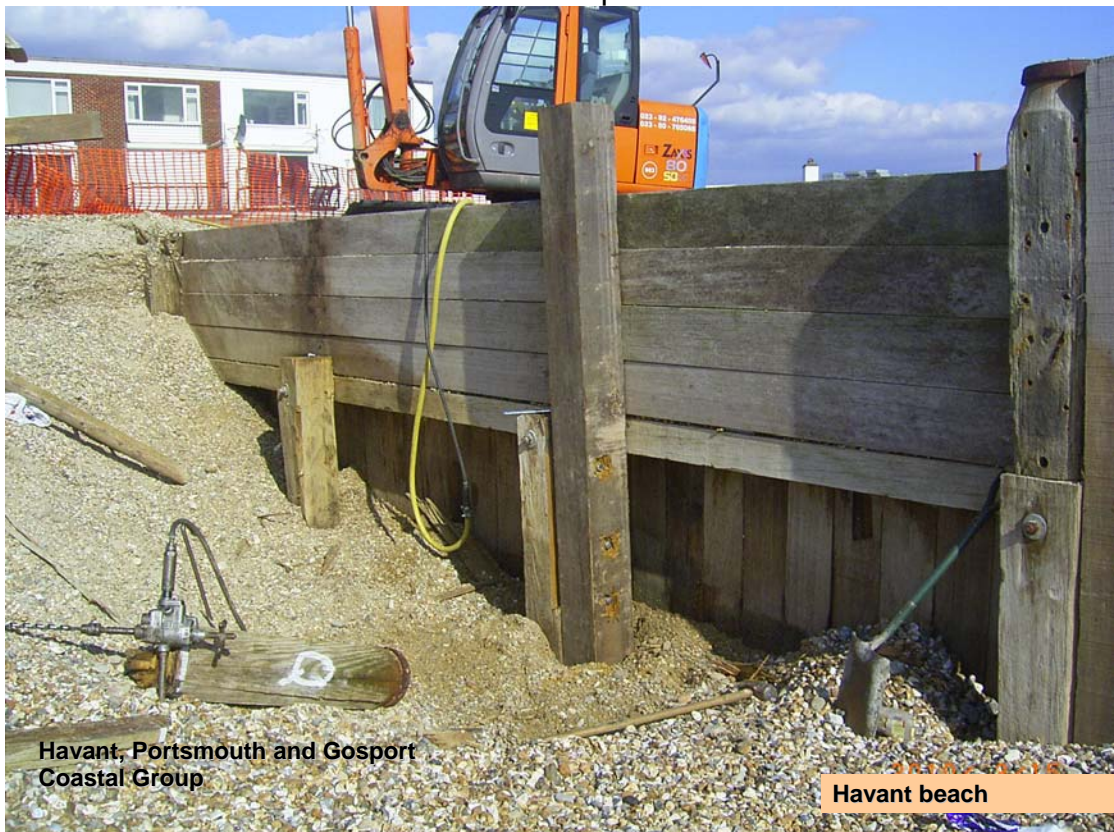
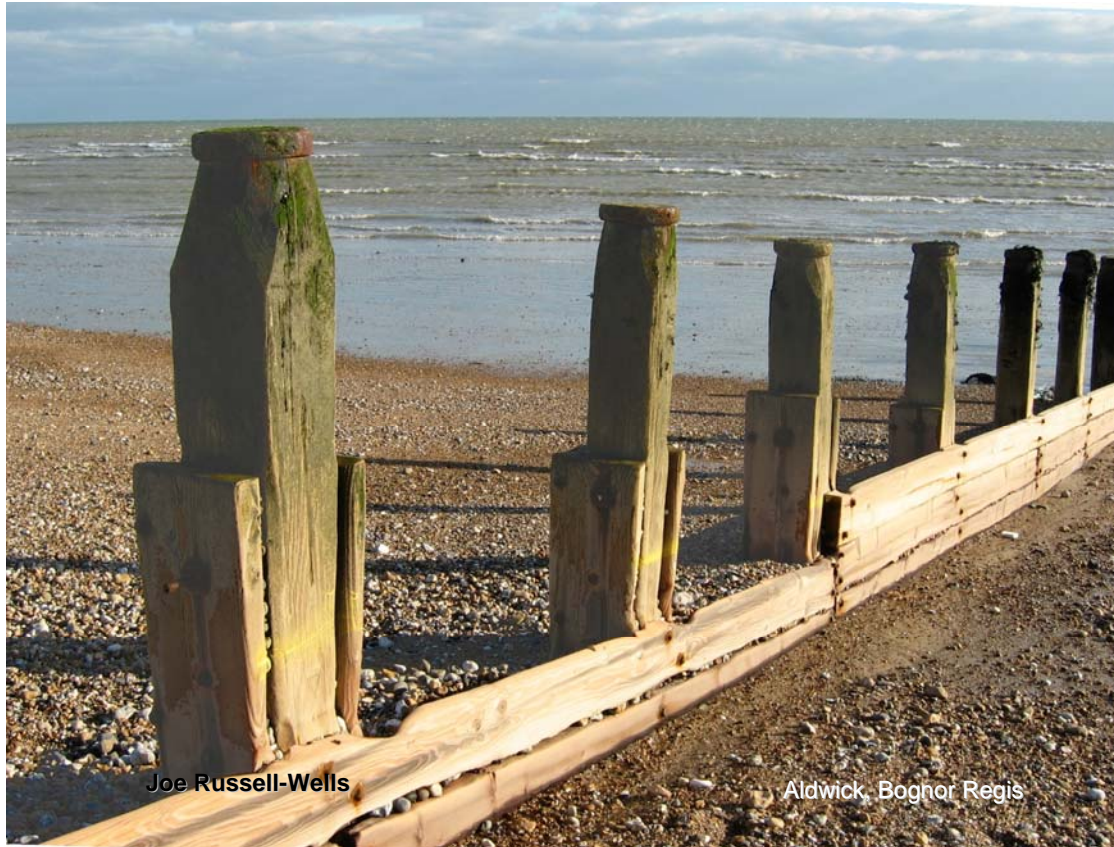
The groynes are approximately 10 years old. Question: How do you stop the shingle abrasion which effectively wears out the timber and hence reduces strength and serviceability over a relatively short period?

Why is the protection around only 3 sides? Where are the other planks?

- To reduce abrasion, use sacrificial timbers from softwood planks, similar idea used by New Forest at Milford with pile protection.

- The protection is located on the sides likely to be most damaged. It looks as though the planking isn't high enough and appears to be on the wrong side.

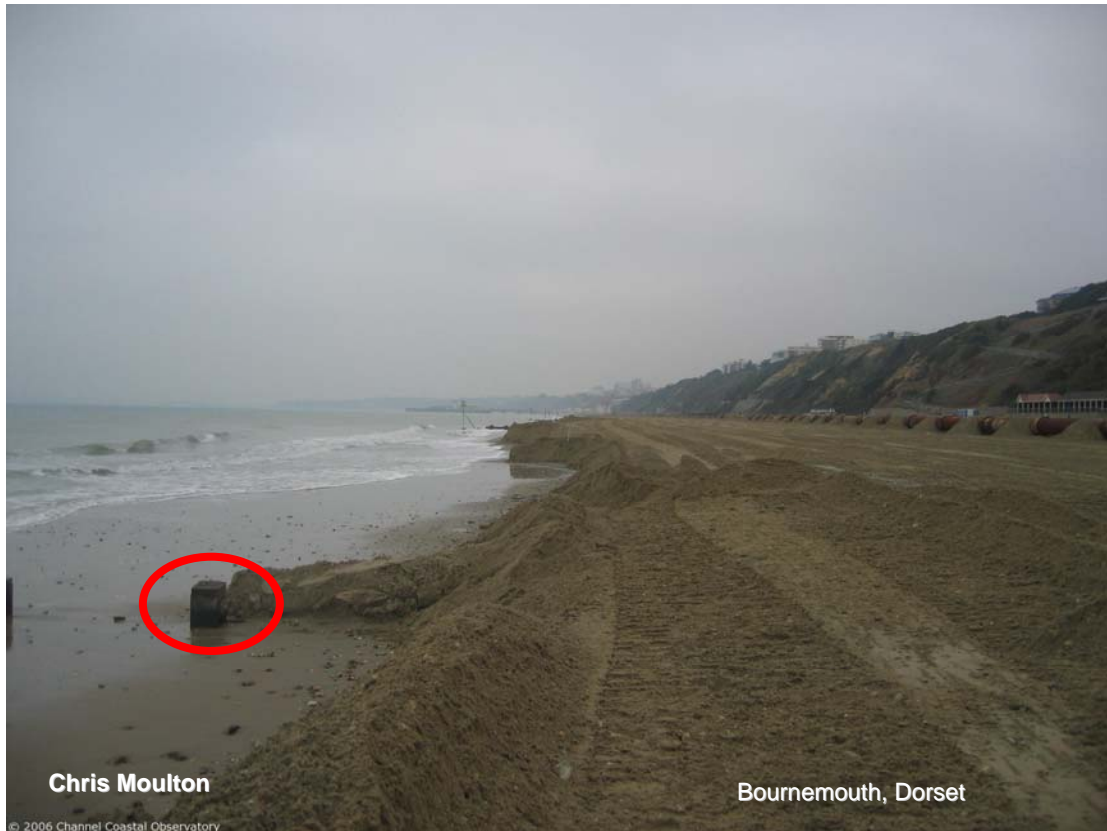
When replenishing the beach at Bournemouth, some of the groyne bays were filled to the top of the groynes. Why does this happen? Does it affect how the groyne works?

- DH: The main reason is that piling the new sand above Mean Low Water makes surveying the new material added to the beach much easier.
- The beach will reach its equilibrium profile naturally in approximately two days, so the short-term burial of the groynes doesn't matter.
- At Hayling Island, the replenishment was placed a little higher than the usual wave run-up level, so cliffs up to 2m high formed, which were dangerous. Residents objected to the high crest level, which obscured sea views.

At Bournemouth, by designing the replenishment crest below the ultimate natural level, the sea pushed sand up the beach slope to form a natural looking beach crest, at a much higher level than the public would have accepted by bulldozing.

- This also prevents coiffing because sediment is moved up the beach, not down. As the sea does the work, filling the profile down to the depth of closure, the cost of plant, and Health and Safety issues below MLW is avoided.

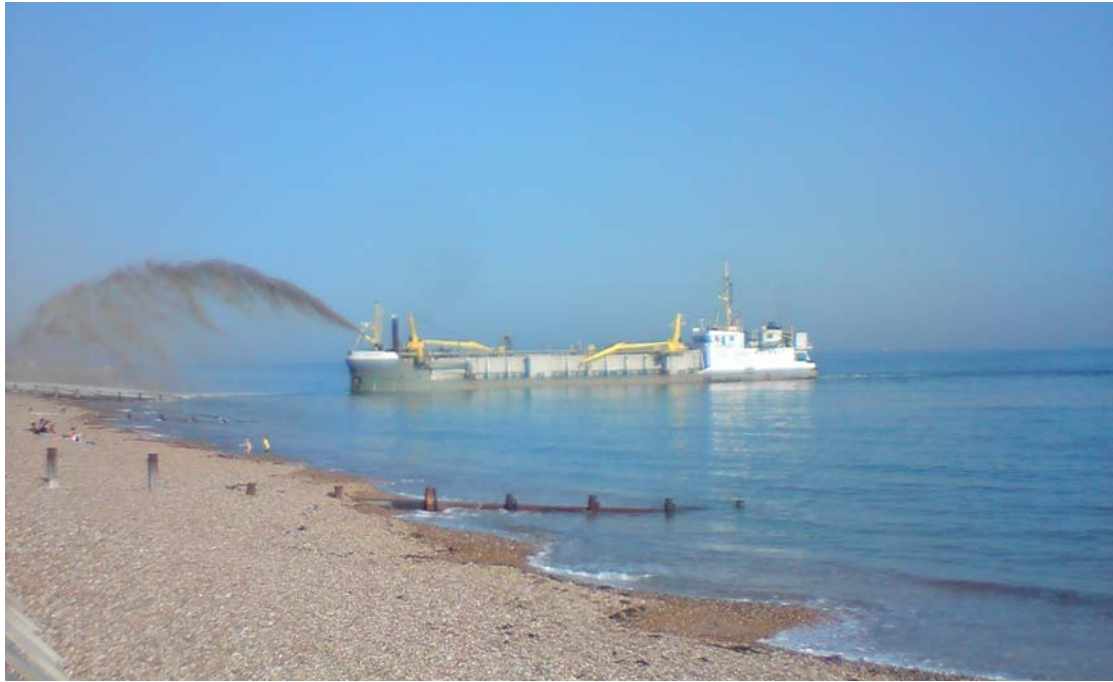
Hayling Island, Hampshire

If groyne bays are full up like these, are they deemed to be a success in terms of coastal management?

- MB: Groynes work to maintain levels, still have to recharge as this only slows, not prevents the drift process; groynes act as speed-bump to erosion.

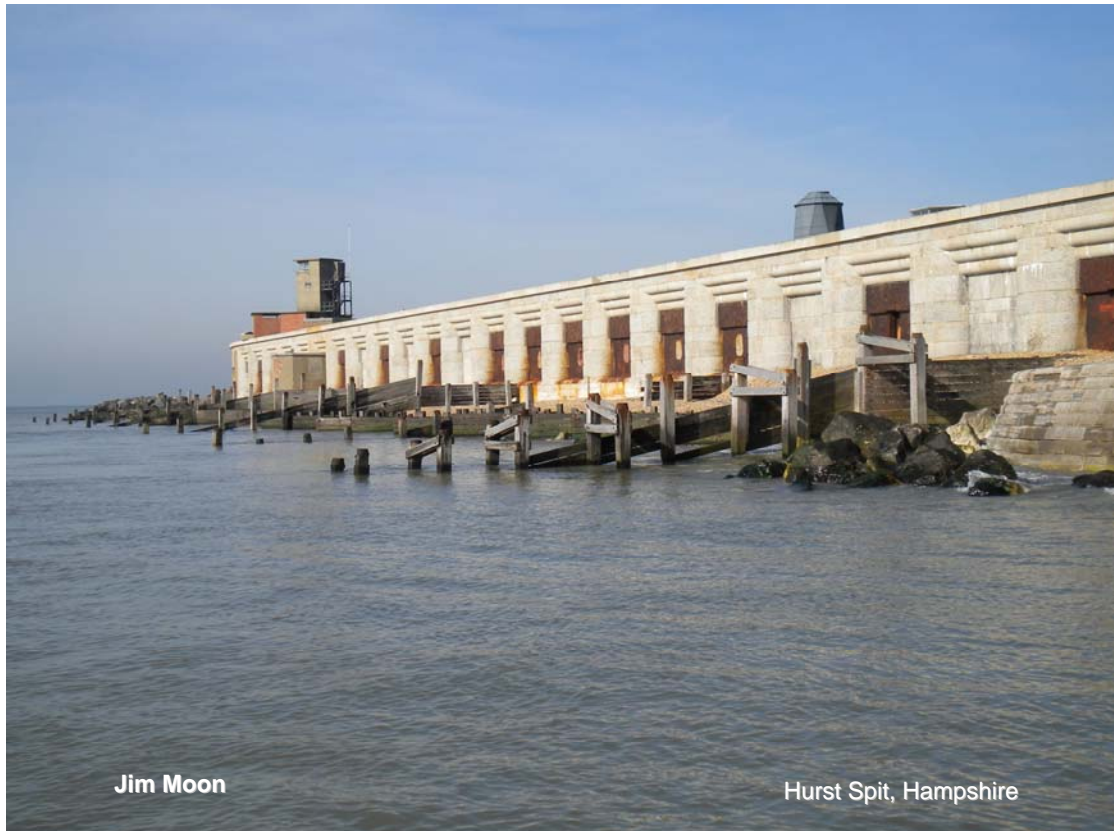
Has timber shuttering at the back of the beach been implemented to store sediment between the castle walls and the shuttering to provide an additional barrier? Also, the groynes are very closely spaced, is this in an attempt to store as much sediment as possible within a smaller area?

- AB and Harry: The groynes here have existed in one form or another since the 1600. They are not efficient because of severe erosion of the seabed. The groynes fall under the remit of English Heritage, which doesn't have a large budget for maintenance at this site. Maintenance does not seem to be ongoing.

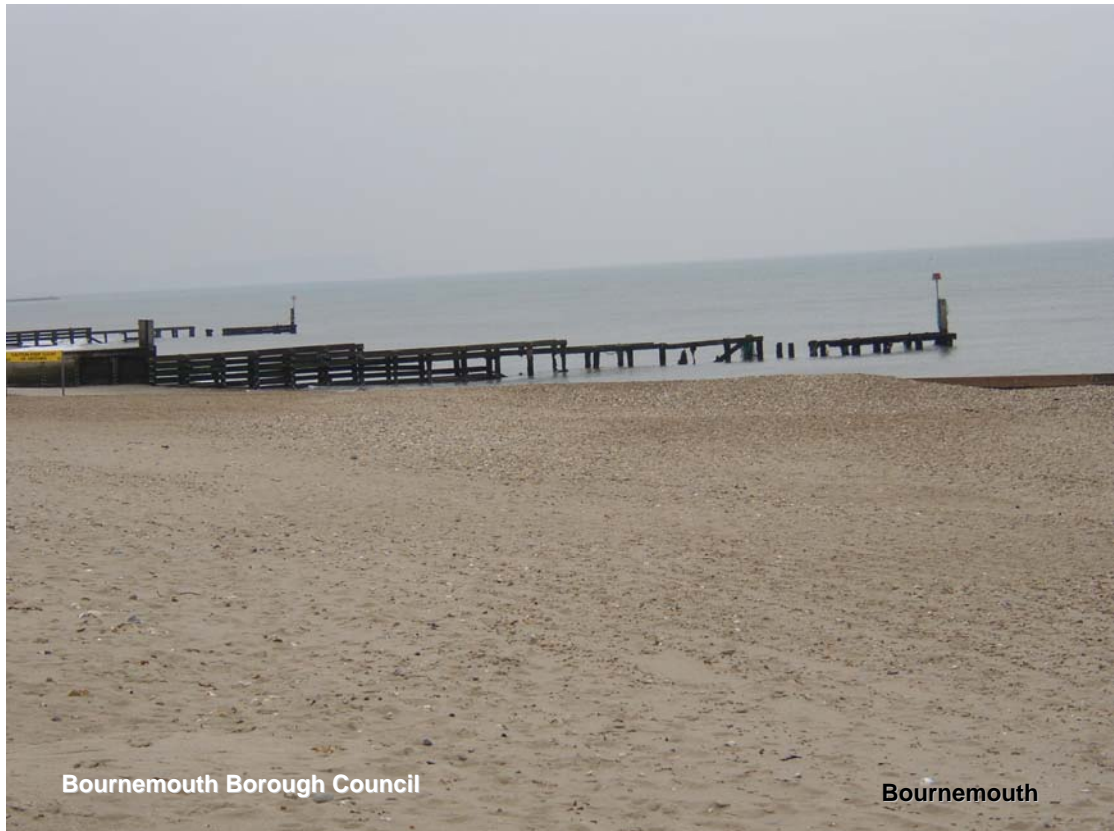
Is a permeable groyne an oxymoron?

- All agree.

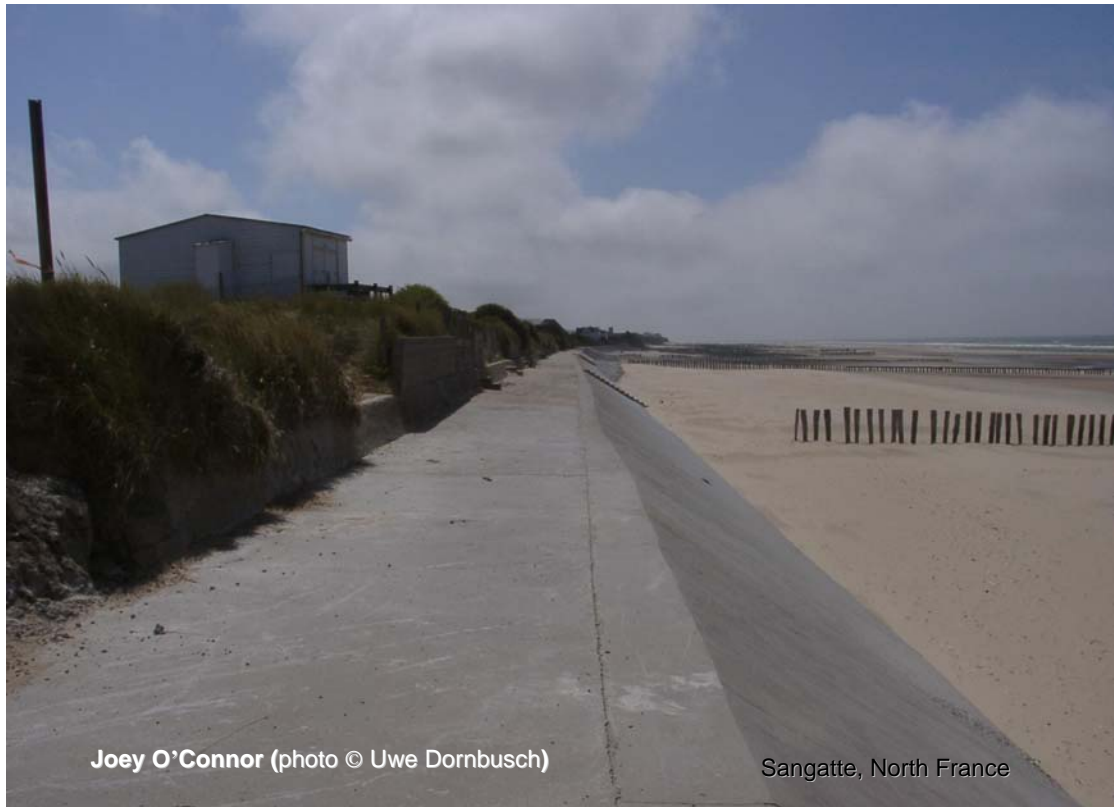
The groyne piles seem to be spaced quite widely apart, and I would ask how efficient these types of groynes are compared to solid groynes, especially with smaller grain sizes.

- Again, the problems with permeable groynes and large spaces. AC: It's likely that the only reason they're still there is that there's a huge cost for removal.

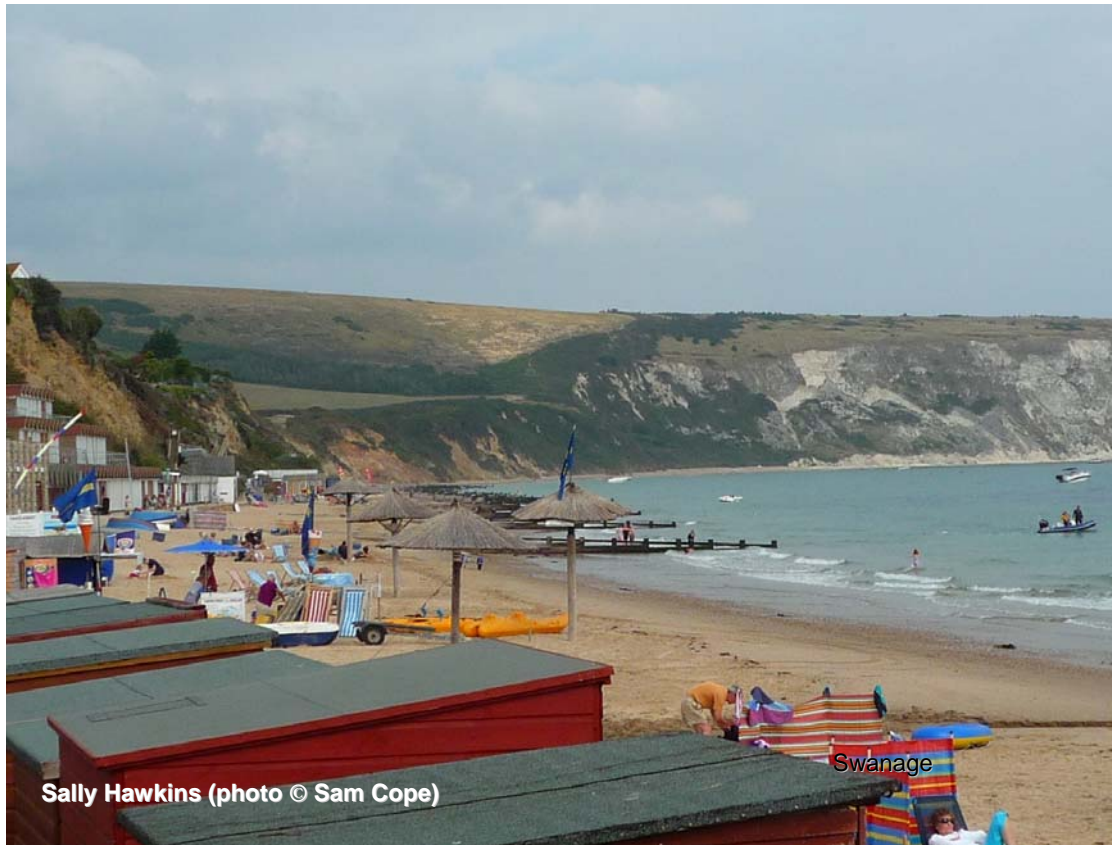
Swanage groynes – why are piles so thick?

- DH: Consultant followed the Bournemouth standard of pile thickness but aren't really necessary as Swanage is much more sheltered. Shows that transferable designs don't work.

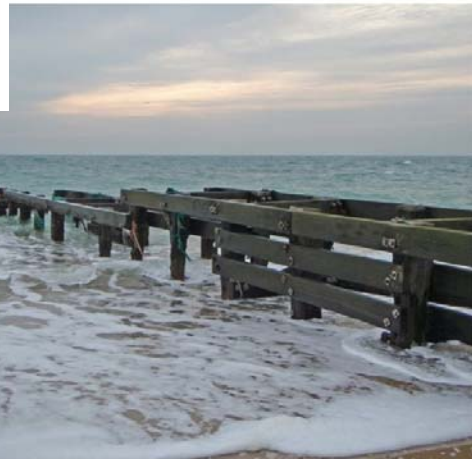
What is the reason behind this double groyne at Southbourne?

- DH: The original design was for a permeable groyne, but it was never effective. It was very susceptible to damage. The exposed end has recently been replaced with rock. The 2 remaining concrete groynes have proved to be the best but they are very expensive to replace. Rock is generally the easiest option.

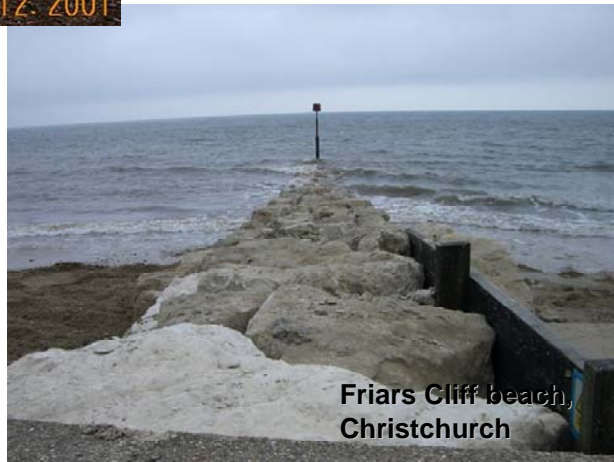
My example is of an old timber groyne which we converted to blockarmour on Friars Cliff beach.

- SW: The timber groynes were slowly converted to rubble/rock armour as the remaining timber was falling down. If the damage is at the seaward side of the groyne, repairing a wooden groyne can be difficult and expensive, whereas replacing with rubble is much easier. When working out the costing, the conversion practice is (in the long run) cheaper and quicker than simply replacing timber groynes. As the groynes are basically self healing, they only really require regular topping up every 2 years, which is more frequent than timber maintenance, but still works out cheaper.
